Skeldon steam plant

Submission on Factories to the Guyana Sugar Corporation Commission of Inquiry

OCTOBER 2015

FACTORIES

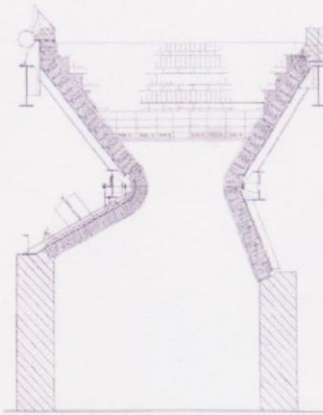
FIG 1: Existing Suspended Arches

The arches and attendant steelwork were entirely dismantled before the start of civil works to accommodate the coarse and riddlings hoppers.

The new furnace construction is of the parallel sided, refractory lined and steel cased type.

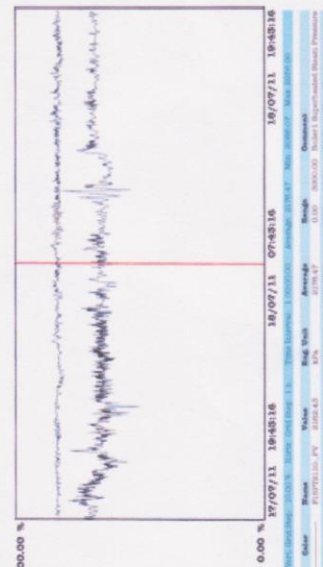
FIG 2: Steam Flow/Pressure Chart after Retrofit.

Manual de-ashing was also hazardous due to unstable combustion and associated puffing.

Subsequent to the retrofit, uninterrupted outputs of 40 t/h and above have been achieved without any manual intervention.

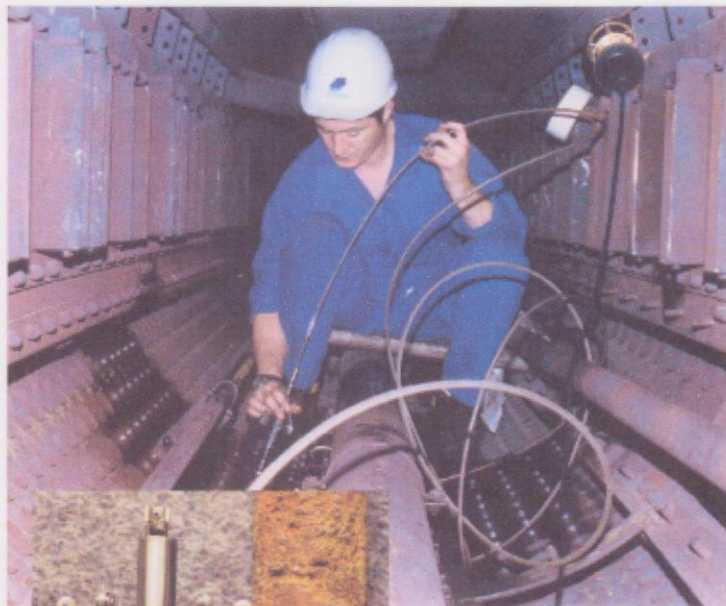
IRIS boiler tube inspection.

IRIS probe and corroded boiler tube.

5.1.6 **Boiler retubing.** Factory Operations staff have advised that the present condition of the tubes of #2 Boiler (some failures are already occurring) indicates that complete retubing of the #2 boiler will be necessary in approximately 2 years. Factory Operations has estimated, based on the actual cost of partial retubing of #1 Boiler, that this complete retubing is likely to cost approximately US\$4 Million. It is recommended, however, that, prior to undertaking this expenditure, an internal Non-Destructive Testing of the boiler tubes be undertaken by a Company that specialises in IRIS (Internal Rotating Inspection System) testing on a regular basis. SteelTest of South Africa is one such Company that can bid to do this job (see **Appendix Fac Ops 5**). This NDT examination will determine whether complete or partial retubing of the boiler is necessary. The interior surface of the tubes must be cleaned of all scale prior to this examination. The budget cost of the IRIS examination, excluding local costs, is approximately US\$ 12,000.
